HELICOPTER BLADE MONITORING

HeliGator

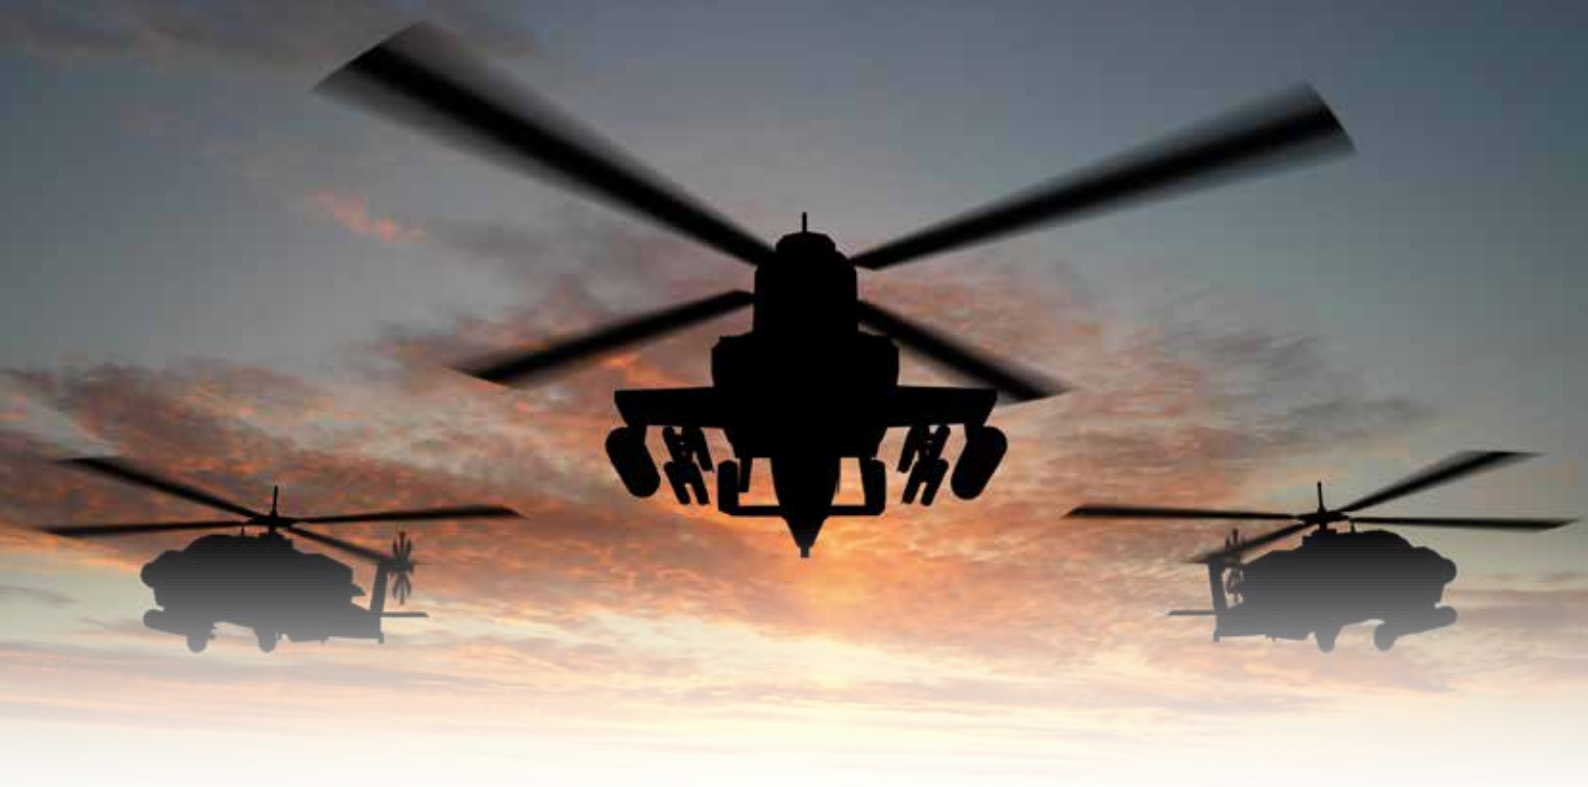
Since December 2017 Technobis FBG Interrogator systems are being Flight Tested on a helicopter with an Integrated Photonics based Multi-Channel Miniature fiber sensing device called *HeliGator*, directly mounted on the root of the helicopter blade. Measurement data was recorded and wirelessly transmitted to a central processing CPU located in the avionics area.
